A Accredited Inspection Service, Inc.
6742 Forest Hill Blvd # 271 , West Palm Beach, Florida 33413
888-381-6651

Client: Joe rust
Property Address: 123 Sulfur Way.
City State Zip: Anytown, USA
Date: 8-13-09

INSPECTION TYPE AND GOALS

The goal is to confirm if the property contains Chinese drywall.

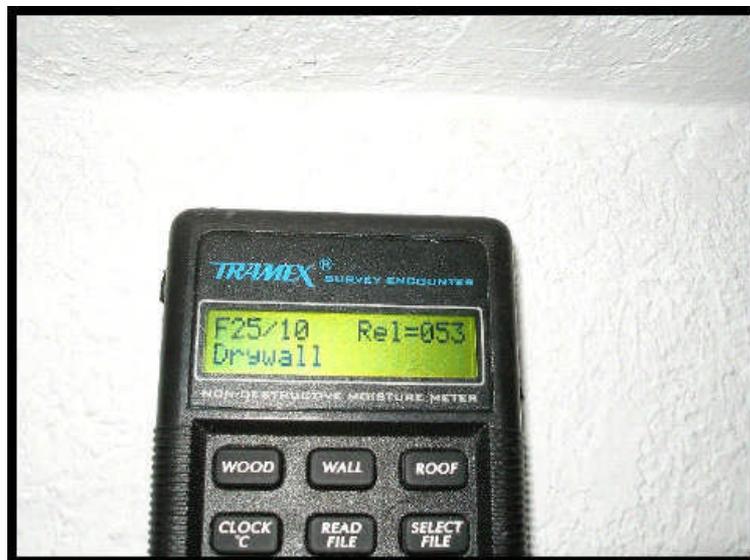
Stock photo of moisture meter.

Moisture meters are hand held devices that pass tiny electrical charges or radio waves through surfaces to determine the moisture content in the surfaces being tested. They are helpful for measuring the moisture content in a building materials following water damage.

Moisture meter testing in the areas tested indicated no elevated moisture levels at the time of inspection.

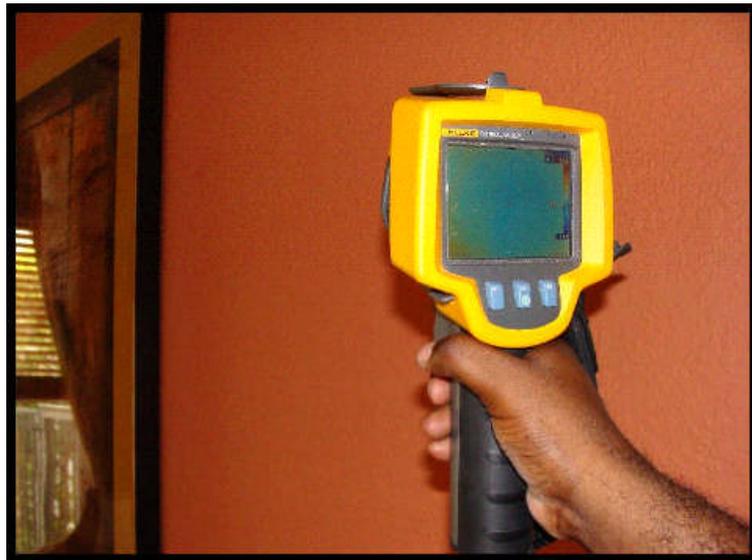
This is a stock photo of a IR or Infrared camera, such a device was used to scan for moisture at your property. Infrared cameras measure levels of infrared light being emitted off surfaces, these levels are translated to temperature readings by the camera that in turn will typically correspond directly to the amount of moisture evaporating off a surface.

Various surfaces were scanned with an advanced device known as an infrared camera, this device detected no moisture in the areas scanned.

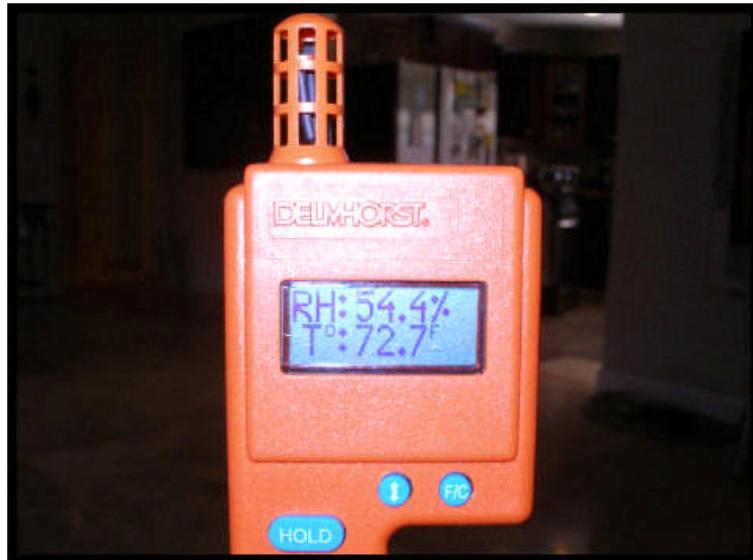
Stock photo of humidity meter.

Indoor humidity at the area and time of testing was: 58%RH, at 76 F
This was a satisfactory indoor humidity reading.

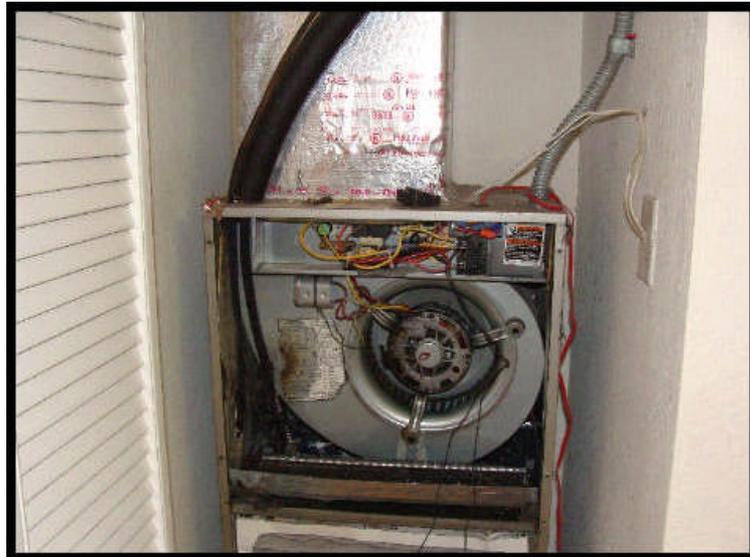
The photo is of the interior of the AC unit. Note black corrosion on the refrigerant lines on the left.

All the above photos are indications that copper in the property was experiencing unusual corrosion consistent with exposure to sulfide compounds from defective Chinese drywall.

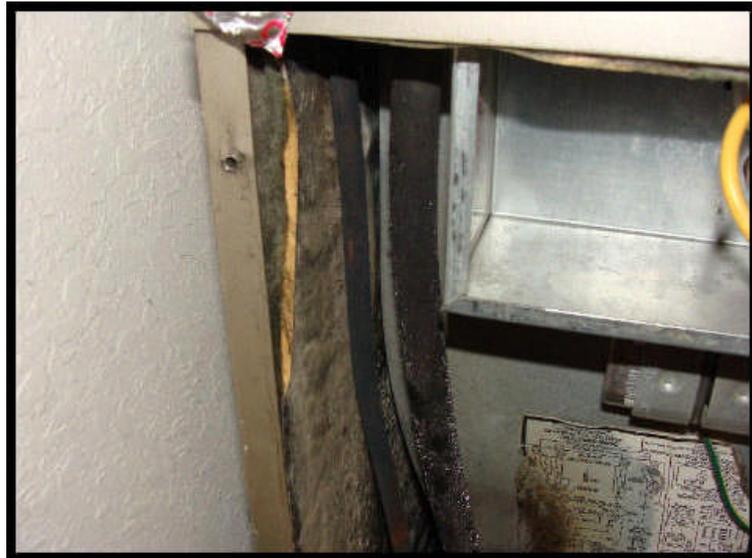
The photo is of the interior of the AC unit. Note black corrosion on the refrigerant lines on the left.

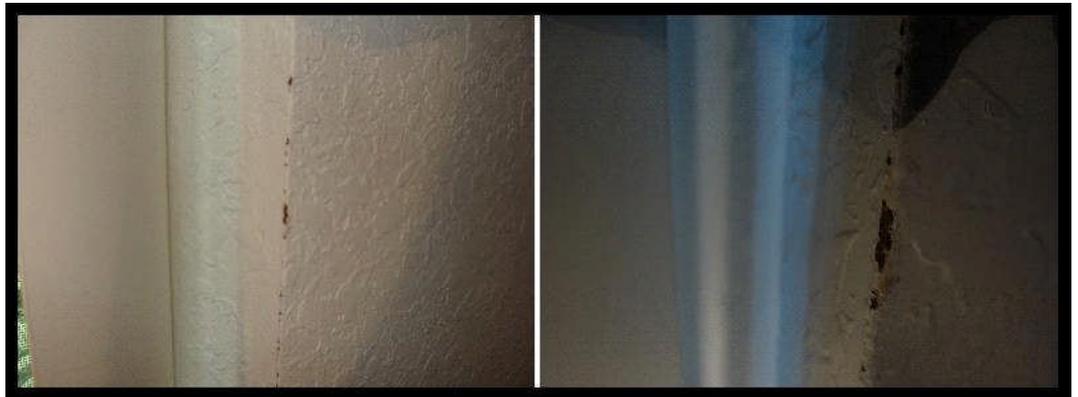
The left photo is of rusty corner molding under paint, the rust is expanding and bursting through the walls paint.
The right photo is of a close up of the same condition.

This was occurring throughout nearly every room of the property.

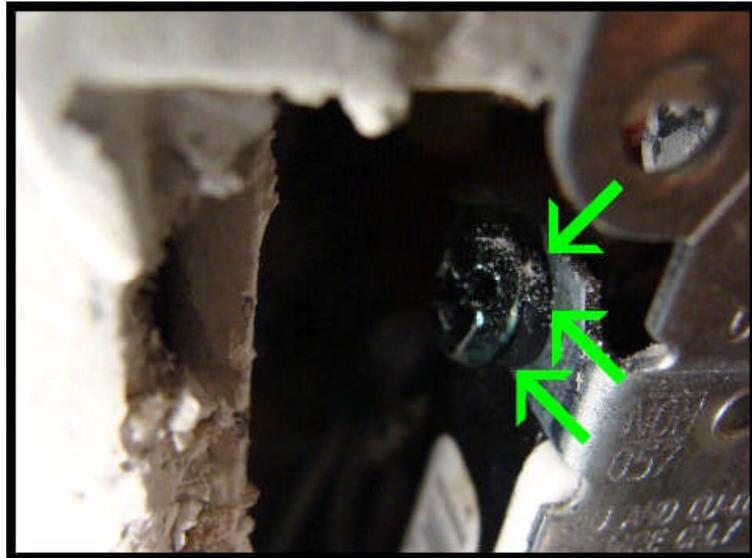
Ground wire should be shiny copper color. It is black and almost impossible to see inside this light switch junction box in the clients wall.

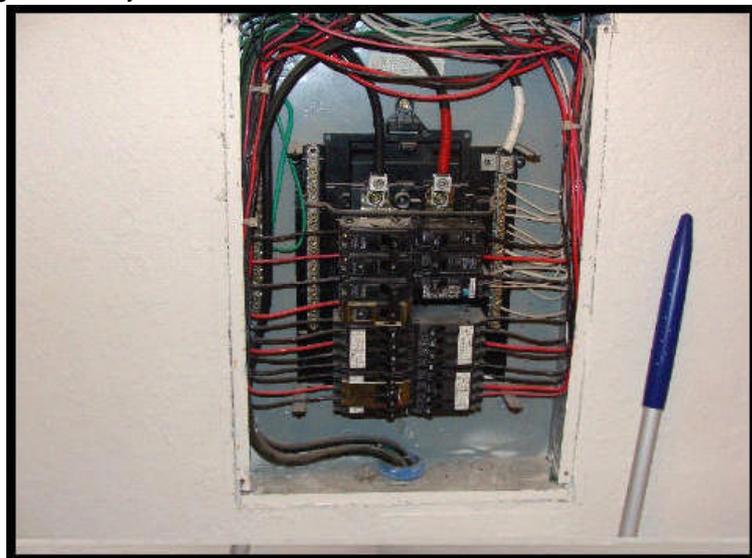
Wires in the breaker panel were also black.
