**A Accredited Inspection Service, Inc.**  
**6742 Forest Hill Blvd # 271 , West Palm Beach, Florida 33413**  
**888-381-6651**

**Client: Joe Smith**  
**Property Address: 123 Moldy Wall Street.**  
**City State Zip: Anytown USA**  
**Date: 8-2-10**

## **INSPECTION GOALS AND INTERVIEW INFORMATION**

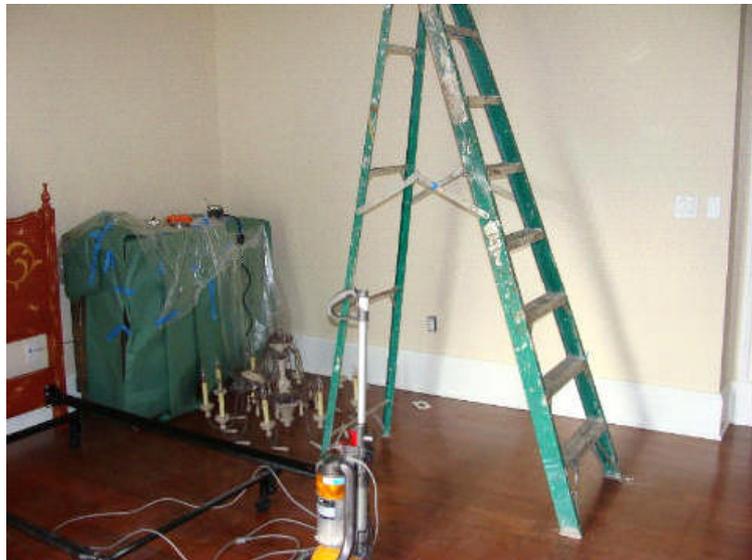
Very little evidence of mold and moisture was found on the walls.

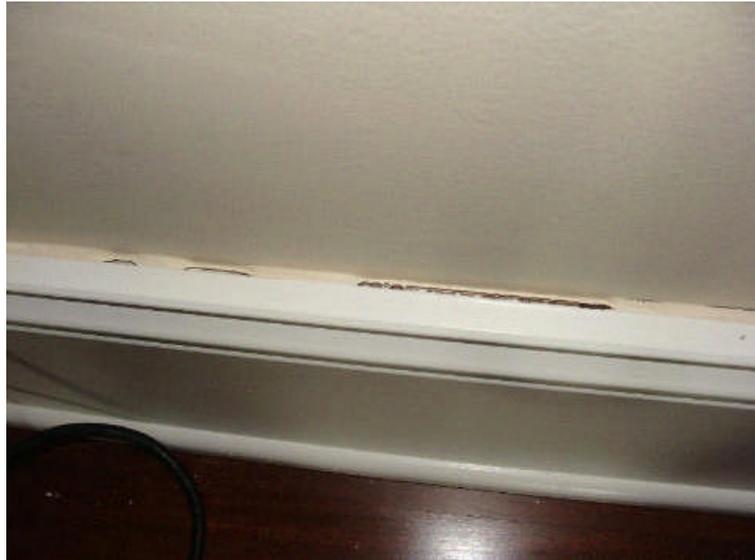
One section of baseboard 18 inches long was separating from the wall in this same room, this is a sign of moisture being absorbed into this baseboard.

This same section of the wall was moist to the touch.

The above is a photo of the baseboard separating from the bottom of the wall in the first photo above. This is evidence of moisture in this wall.

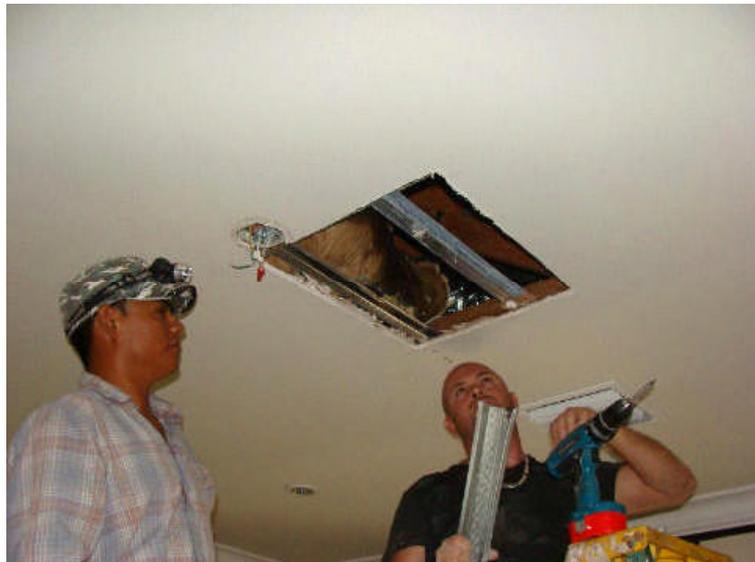
In the guest bedroom mold was observed inside a one square foot hole in the ceiling.

The above is a photo of a hole in the bedroom ceiling.

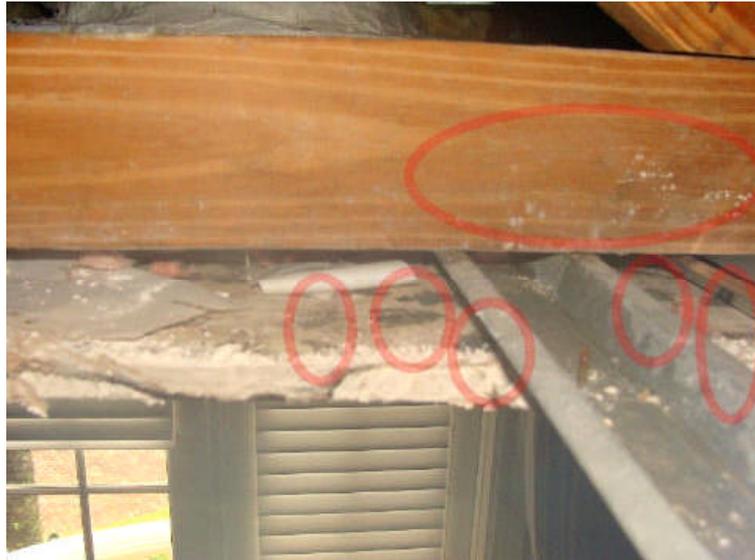
Note mold on the floor of the attic as observed from inside this ceiling hole.

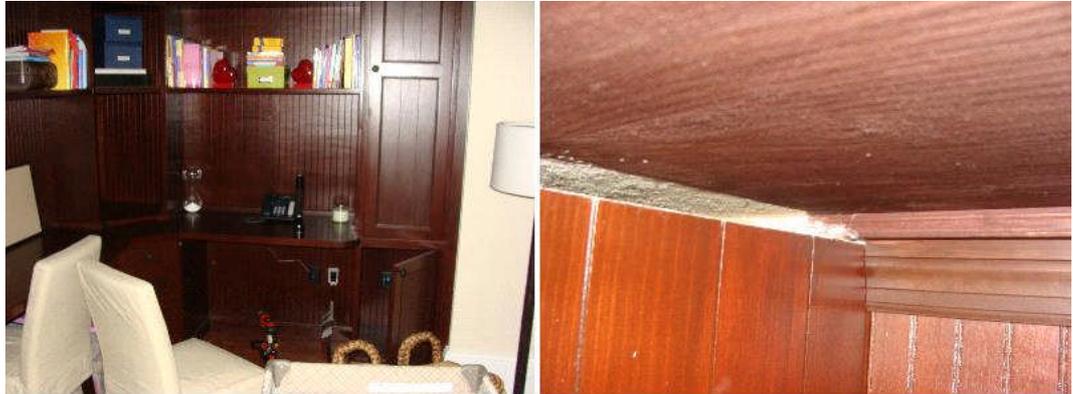
The above left photo is of the build in desk.  
The above right photo is of a close up of the desk underside with mold expanding out from seams in the desk's wooden panels.

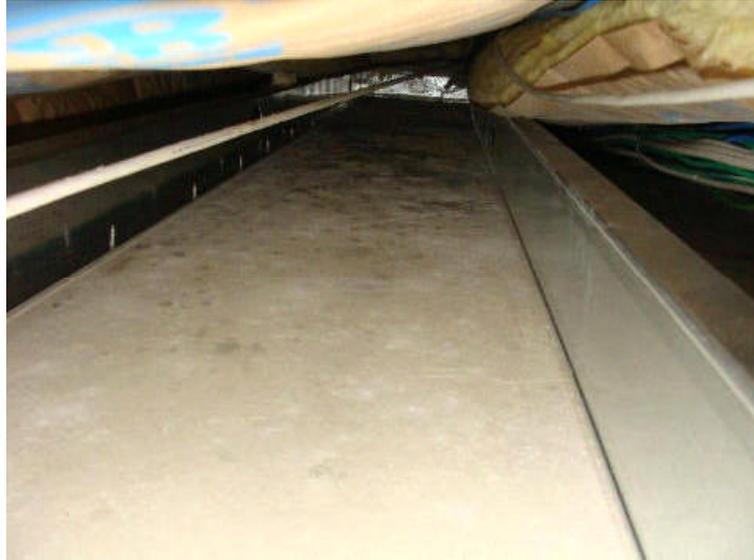
Mold was observed inside the walls from inside the attic. The amount of mold was extensive. Many types appear to exist in the walls and odors were strong. Mold was observed in the walls from the open tops of the walls accessible from under the attics insulation.

The above is a photo of mold inside the wall as viewed from inside the attic by looking into the hollow openings at the top of the wall.

Specific recommendations start here: Remediate all upstairs walls from floor to  
ceiling and remediate all upstairs ceilings.

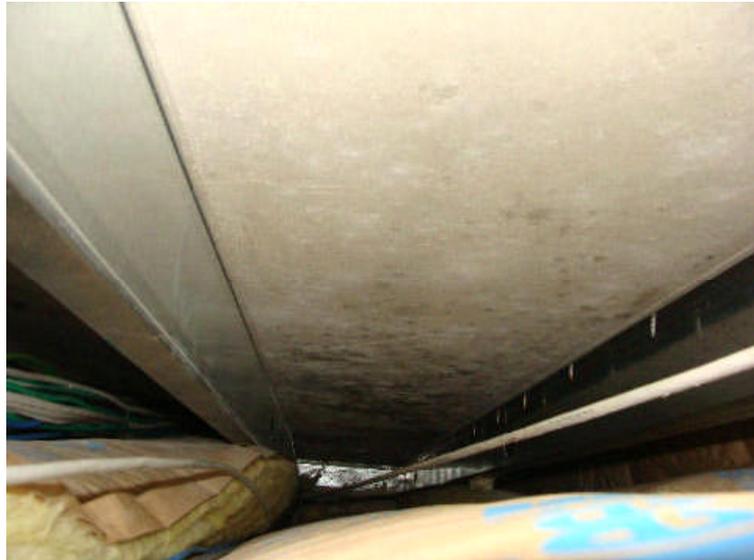
The above is a photo of mold inside the wall as viewed from inside the attic by looking into the hollow openings at the top of the wall.

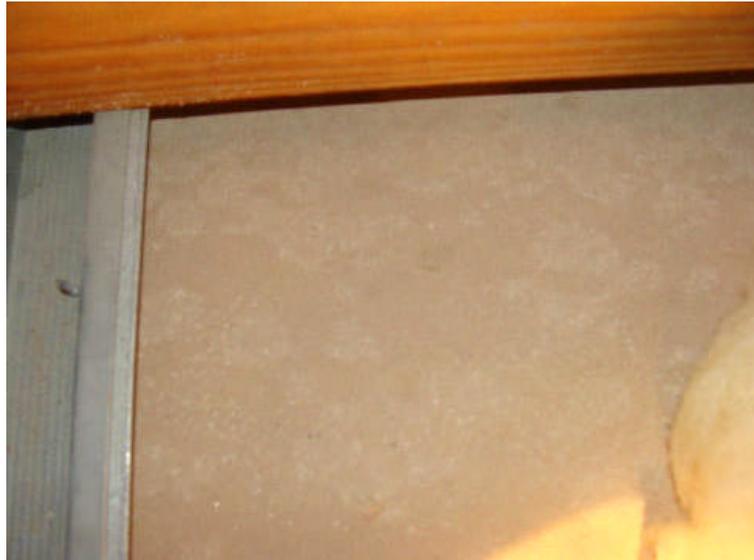
Mold was also on the top of the ceiling, this is the floor of the attic under the insulation.

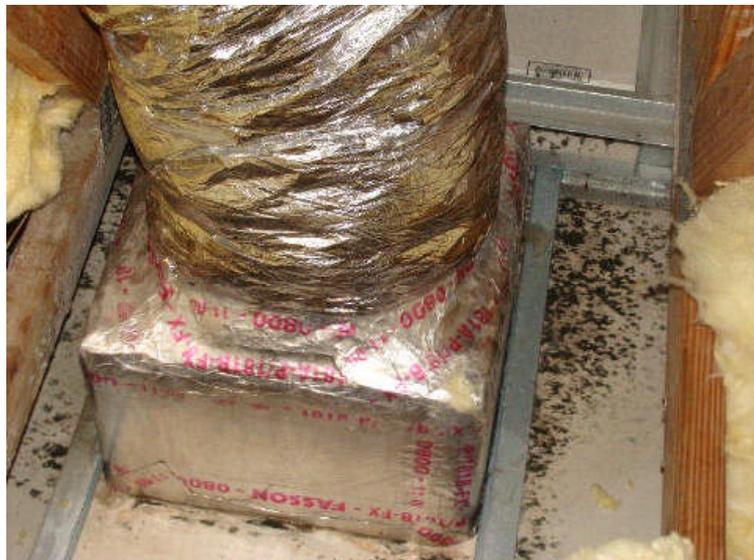
The AC ducts were leaking air in the attic, this causes the AC to pull air out of the house and cool it without replacing all that removed air. As a result negative pressure is created in the home, this negative pressure causes hot humid air to be pulled out of the attic and into the hallow walls. When this hot humid air touches cold drywall cooled by AC use condensation is formed in the walls and mold forms in the walls.

In several areas mold was around leaky ducts in the attic. Leaky ducts caused negative pressure in the home that pulled humid attic air into the cold walls below. The mold around many ducts is all the proof needed to prove beyond a reasonable doubt that the ducts were leaking cold air.

- 1) Seal all leaky AC ducts to help deter attic air from being pulled into the walls.

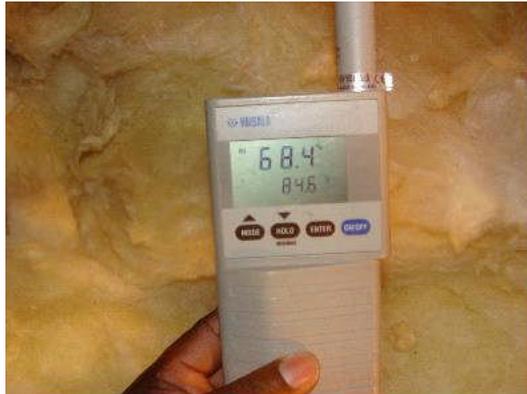
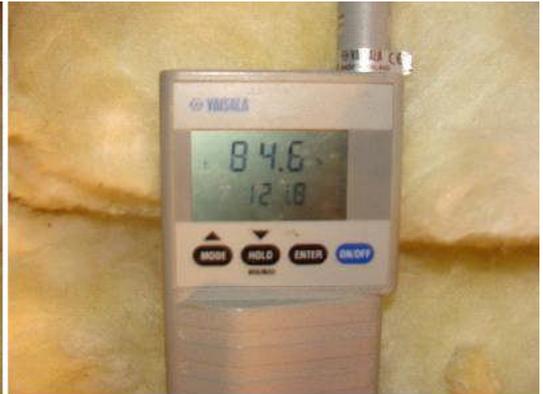
Temperature humidity and grains of moisture were high in the attic.

9) Install a professional quality dehumidifier in each section of the attic in such a way that they are properly drained to the exterior, and in such a way that dehumidifier vibrations do not cause the units to move or fall over.

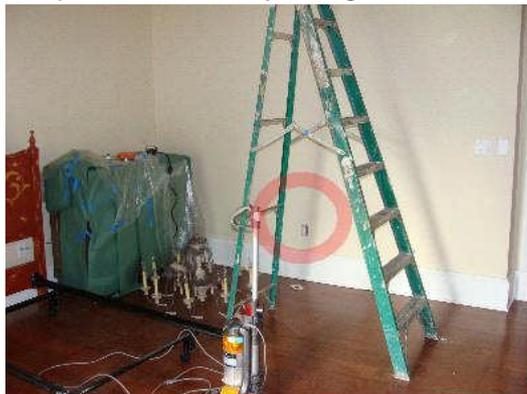
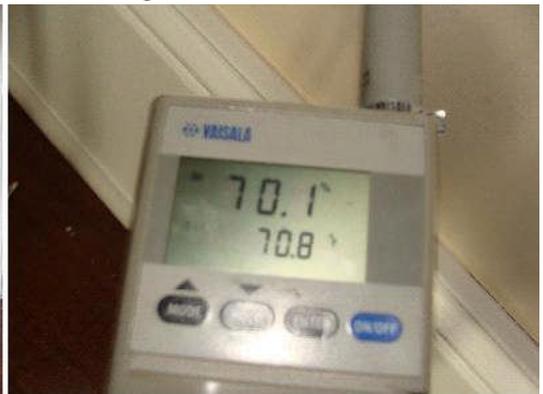
Temperature humidity and grains of moisture were high in the partition walls and in the perimeter walls that abut the exterior. Above is a perimeter wall with humidity problems inside. Circle indicates where measurement was taken of inner wall air.

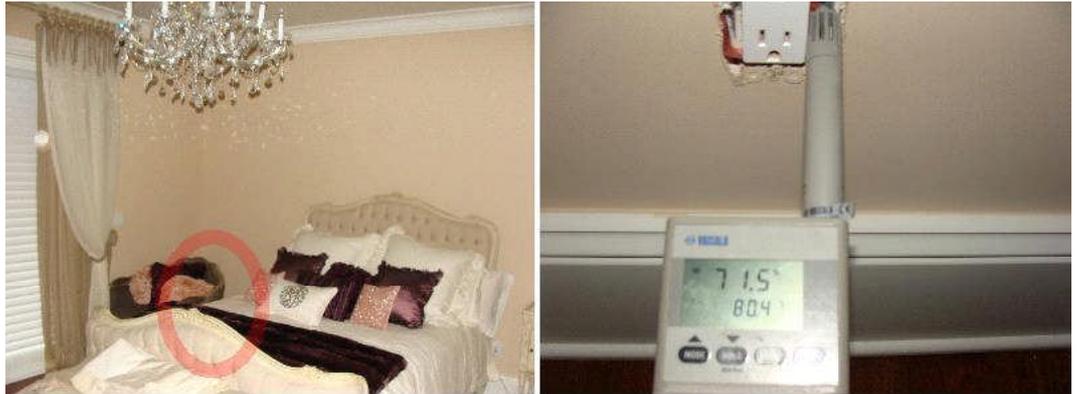
Above is a partition wall with humidity problems inside.  
Circle indicates where measurement was taken of inner wall air.

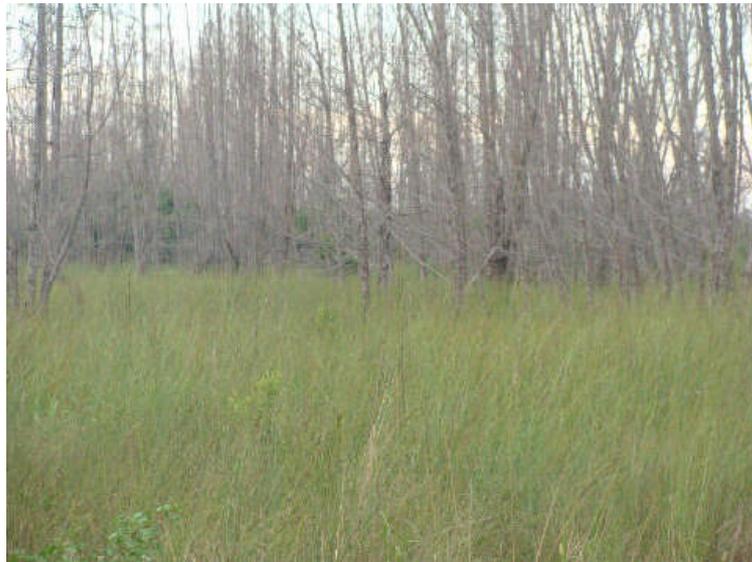
In addition the property is not to far from a large open wetland (the everglades and or water conservation area # 3), thus the open wet area provides no protection from humid winds approaching the house. The body of water can provide extra humidity but your outdoor air already has plenty of humidity most of the year.

Above is a actual photo of the wetland near you. Only a few miles West is water conservation area # 3 or possibly the Everglades it is a vast open sea of water, wet grasslands, and few objects to block humidity blown from this area into your soffits.

7) It is advisable to seal your soffit vents from outdoor air intrusion because it is the outdoor air that is the source of your humidity problem. Seal off soffit vents by the application of icynene insulation in the attic, if this is not adequate to stop air infiltration then install wood over the soffits. Sealing soffit vents may void your roof warranty but it may be the only way to solve your attic humidity problem thus the decision is up to the homeowner. Sealing off soffit vents is allowed by code in the 2006 International Residential Code for One and Two Family Dwellings.
