**A Accredited Inspection Service, Inc.**  
**6742 Forest Hill Blvd # 271 , West Palm Beach, Florida 33413**  
**888-381-6651**

**Client: Joe Smith**  
**Property Address: 123 Clean Street.**  
**City State Zip: Anytown USA**  
**Date: 8-4-10**

This inspection is a post remediation verification inspection also known as a clearance test, it is intended to help determine if remediation appeared to be satisfactory.

## POST REMEDIATION TESTING

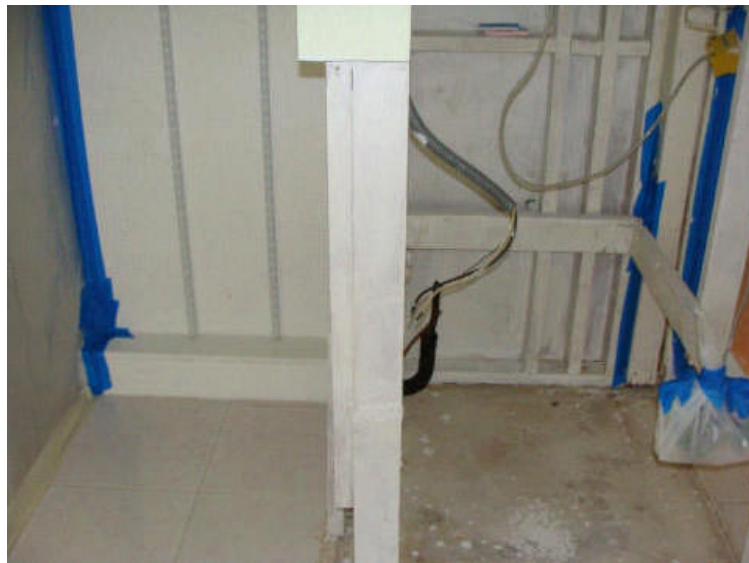
During this clearance inspection the inspector observed the following:  
All previously moldy building materials such as but not limited to moldy drywall had been removed, and exposed surfaces had been cleaned and were dry.

The above is a photo of professional mold removal resulting in no visible mold in this area.

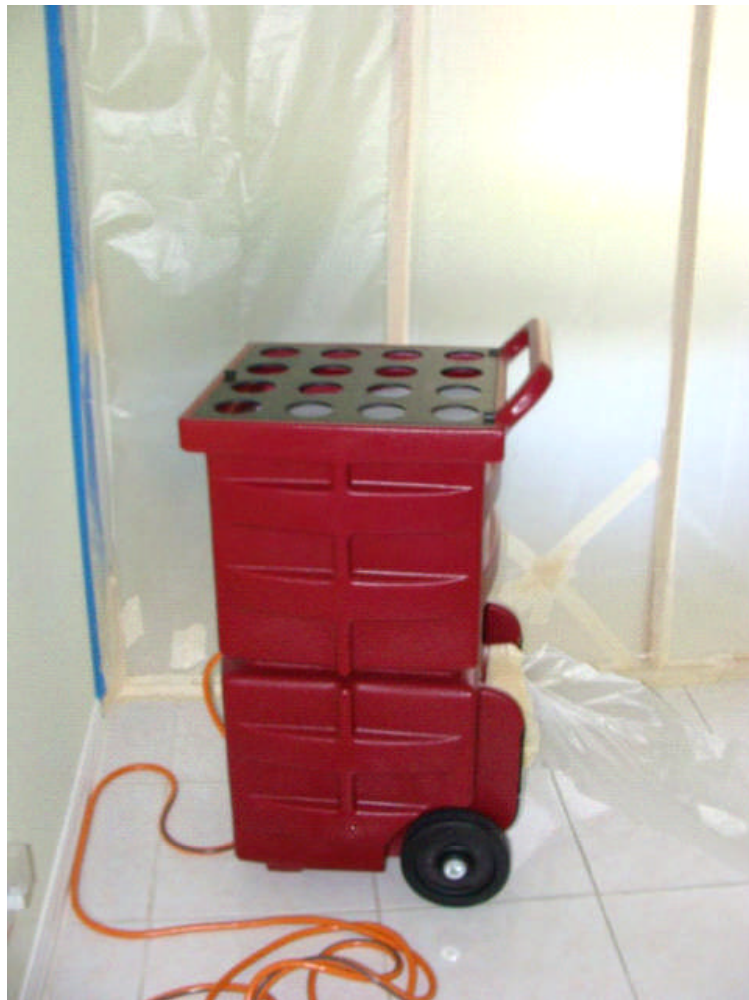
The inspector observed that containment was installed in a professional manner to deter the spread of spores and dust from the work area also known as the containment area.

Professional grade air scrubbers / negative air machines were observed, these machines are used to create negative pressure and to control the levels of dust and spores in the work area.

The above is a photo of containment and an air scrubber.

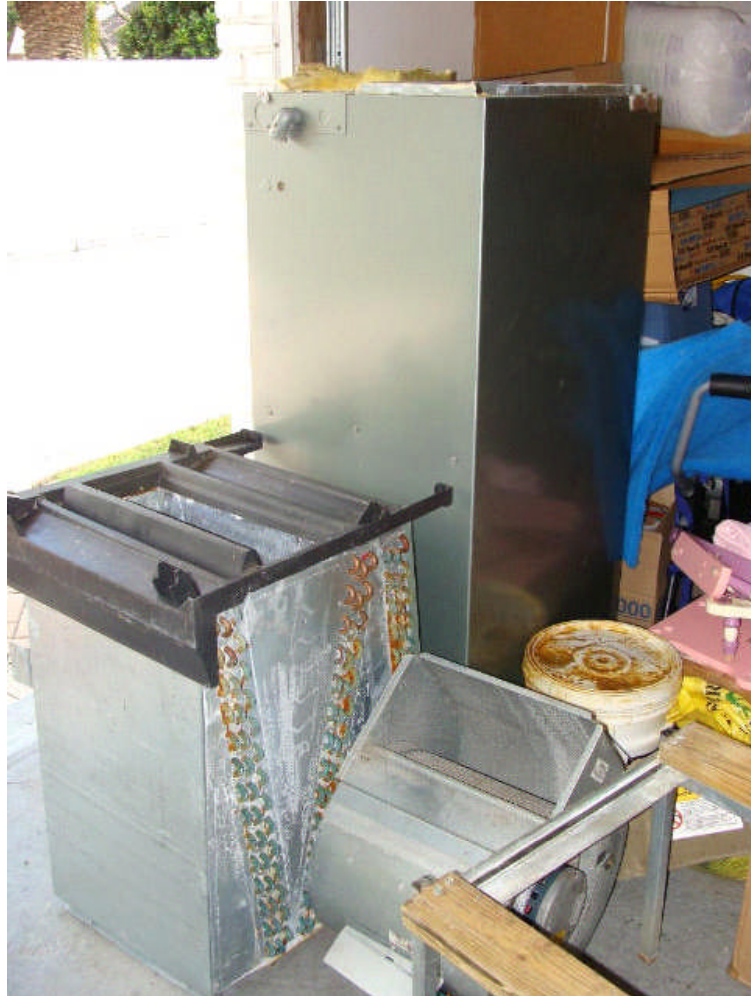
Interior of the AC unit including the coils and pans were satisfactory. Unit had been dismantled and cleaned.

The above is a photo of the various AC components that were removed and cleaned.

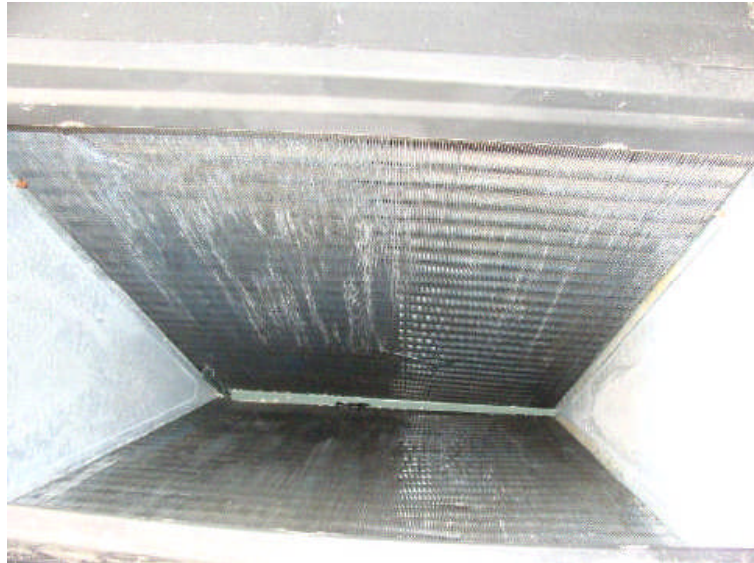
The above is a photo of the AC coils that were removed and cleaned.

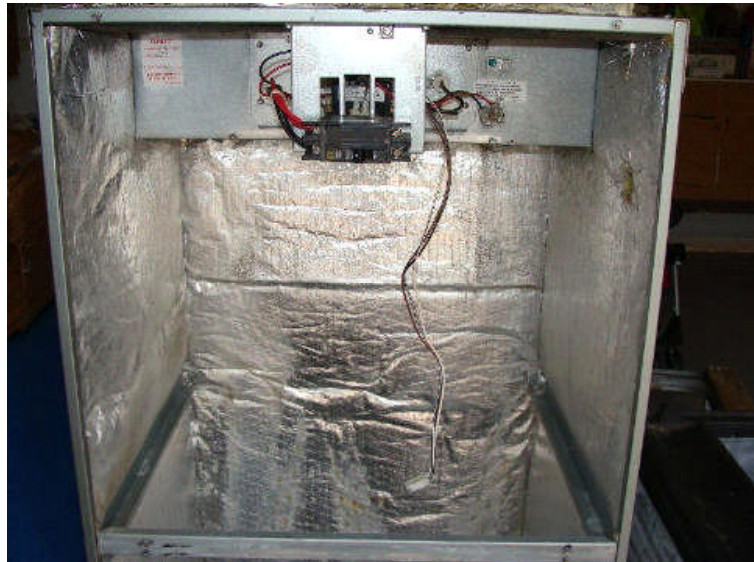
The above is a photo of the AC unit enclosure that was removed and cleaned.
