**A Accredited Inspection Service, Inc.**  
**6742 Forest Hill Blvd # 271 , West Palm Beach, Florida 33413**  
**888-381-6651**

**Client: Joe Smith**  
**Property Address: 123 Easy Street.**  
**City State Zip: Anytown USA**  
**Date: 7-30-10**

## SITE ADDRESS

## INTERIOR ROOM OBSERVATIONS

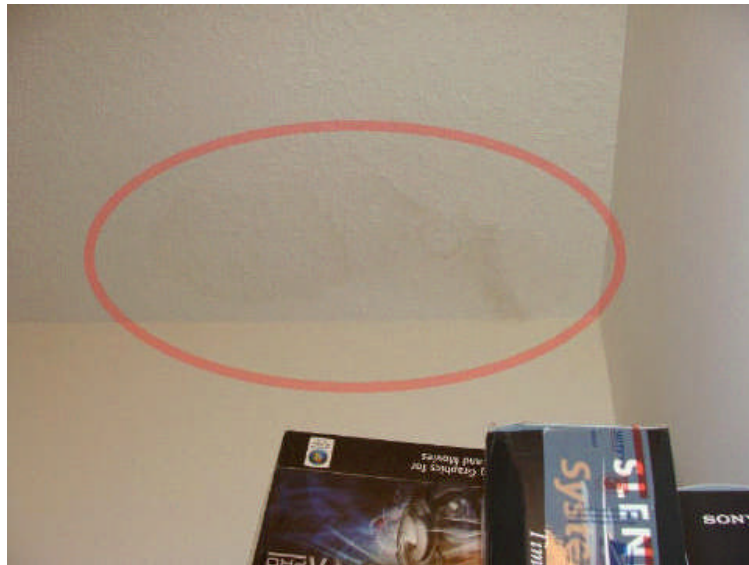
A few stains just a few inches across were observed at the ceiling of the closet, and one stain a few foot long and about one inch wide was observed on the wall of the master bedroom closet. Stains were minor and almost invisible.

Above is a photo of the moisture stain on the closet ceiling.

Observed moisture stains at the ceiling indicative of likely roof leaks. Have all required remediation conducted and have any and all required roof repairs or other needed repairs made. Occupants reported that the roof has been made.

Remove the drywall from the master bedrooms small walk in closet, do this in an area 4X4 foot in the stained ceiling area being sure to remove all mold in the attic above. Remove all insulation from this same ceiling area.

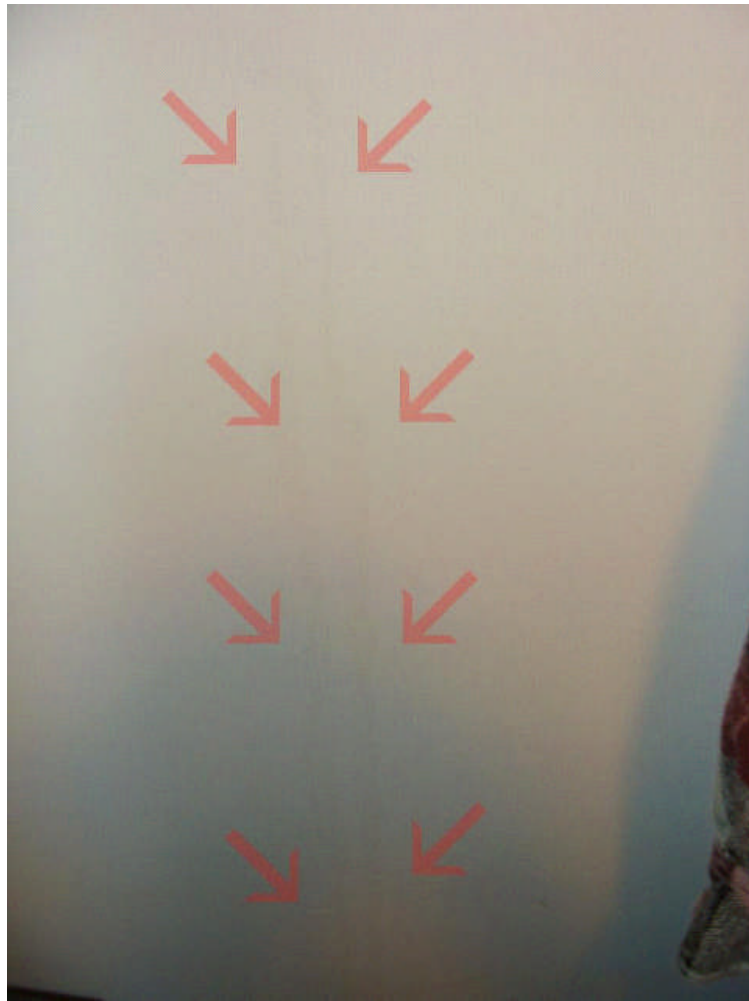
The above is a photo of stains on the closet wall.

Also remove drywall in the stained closet wall area 2 foot side to side, and from the floor to the closet ceiling. This is the right wall of the master bedrooms small walk in closet, (right wall when standing in the entrance of the closet and looking into the closet.)

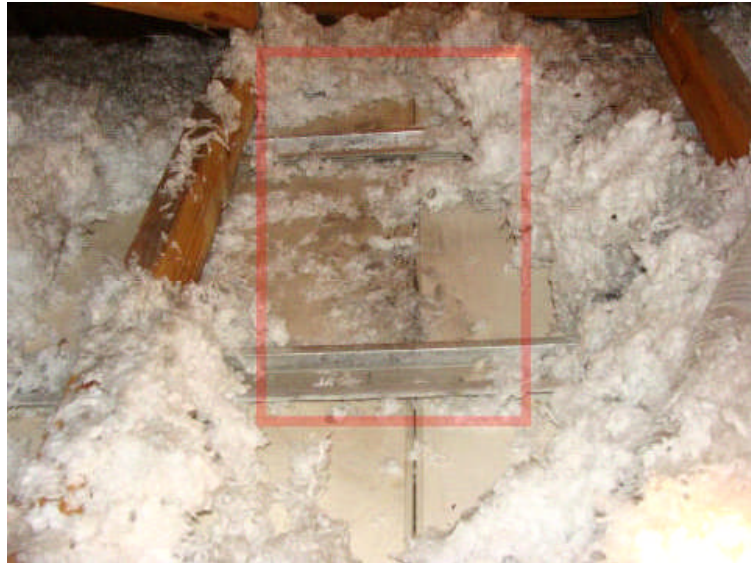
Inner wall testing was conducted in this area, results indicated elevated Pen Asp spore levels in the wall, and Stachybotrys growth under insulation in the attic above this area.

The above is a photo of mold under insulation in the attic above the stained closet.

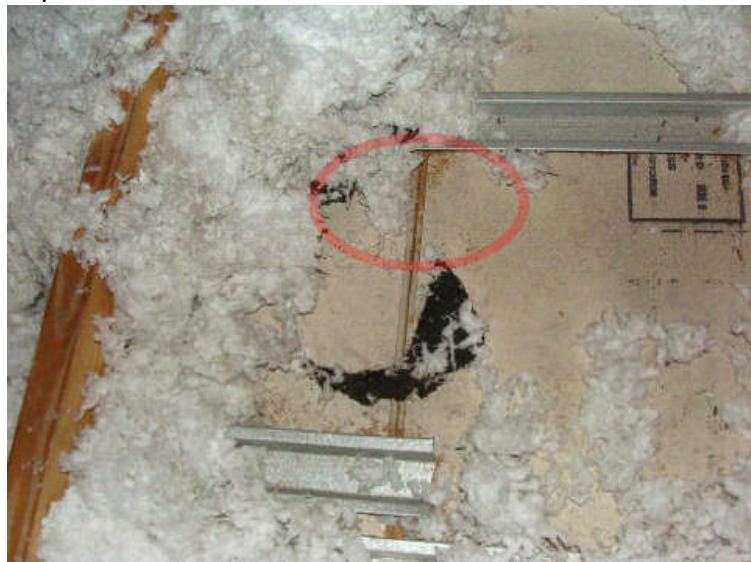
The above is a photo of mold under insulation in the attic above the stained closet.

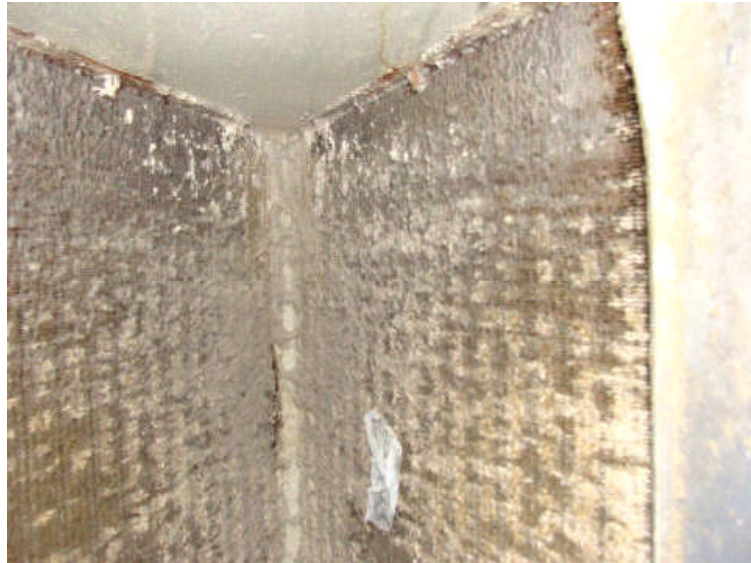
The above is a photo of mold and contamination inside the AC unit, the occupant is recommended to have the interior of the AC cleaned in addition to having the attic and closet problem addressed if air quality is an issue.

Dirty coils can cause air quality problems, and make it difficult for the AC to cool your air.

The occupant reported that the cooling bills are very high. Dirty coils are likely a major reason why your cooling bills are so high.

The bottom side of the evaporator coils on the interior of the air handler were very dirty.

Client reported that the cooling bills are very high, it is extremely likely that this is at least part of the reason why the cooling bills are high.

AC filter likely did not fit correctly in the past. This was the likely cause of contamination.

Have the AC coils, interior, and ductwork and plenums cleaned in accordance with NADCA standards.
