A Accredited Inspection Service, Inc.
6742 Forest Hill Blvd # 271 , West Palm Beach, Florida 33413
888-381-6651

Client: Jane Smith
Property Address: 123 Voc Lane.
City State Zip: Anytown USA
Date: 12-5-06-a

EXECUTIVE SUMMARY

Client requested an indoor air quality investigation to determine the source of odors in and near the front foyer area. This was not a mold inspection.

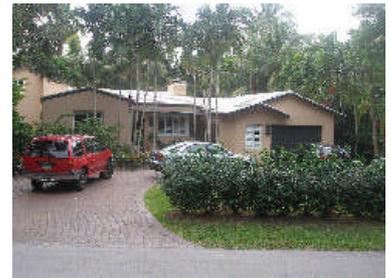
PHOTO 1

The house inspected is an older Coconut Grove house. Client reported that she remodeled the house 6 months ago and has been smelling odors the entire time, client is not sure if the odors started right after renovations or before. Client reported that the odors appeared to be most noticeable in the front 10 foot X 10 foot foyer area and the odors rapidly drop off past the front foyer area. Client has installed new AC units and had the chimney cleaned and has not been able to rid the house of the odor. Furniture in the area were not particle board or other materials that appeared to be likely to release formaldehyde or other VOC's.

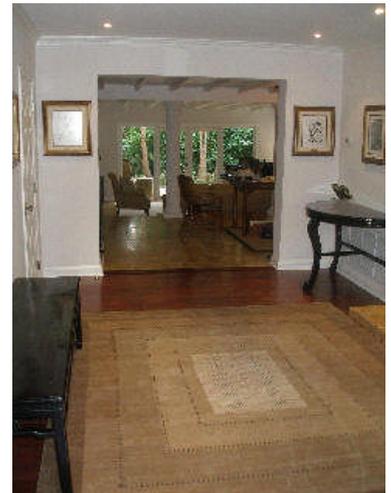
PHOTO 2

Upon entering the house the inspector immediately noticed the odors, the odors appeared to be a chemical odor like a possible varnish or solvent odor. The odors in this area did not appear to be a mold odor. The inspectors initial hypothesis is that the odor may be from the shiny lacquer covered hard wood like floor. However the odor may be from completely unrelated odors.

Floor was installed 6 months age using Permagrane timeless 3 Acrylic plank floor, this is a veneer floor probably made of wood like acrylic veneer over wood boards, this is all installed over the original plywood sub floor with up68 permigrane adhesive.

much of the odor is coming up from under the crawl space through the laminate floor. Remove the laminate floor and replace it with tile. Or cover the laminate wood with a sealant. The other floors in the house were tile and the odor was not detected in these areas.

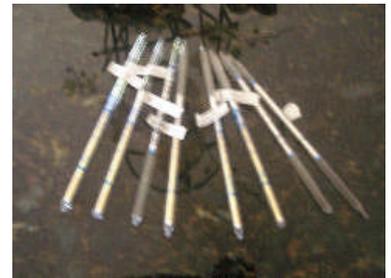
PHOTO 3

Air samples were tested for formaldehyde and indicated no formaldehyde.

It appears from these tests that the odor may not likely be from formaldehyde off gassing products from the floor, painted walls, or furniture.

To the right is a photo of the glass gas detection tubes used, note that many of these tests were conducted.

Gastec gas detection tube system was used to take a air sample from 1 inch above this floor
Measuring scale .05-1.0 ppm
Results below detectable levels at 5 strokes.

Gastec gas detection tube system was used to take a air sample from the center of this room 5 foot above the floor (breathing range)
Measuring scale .05-1.0 ppm
Results below detectable levels at 5 strokes.

Gastec gas detection tube system was used to take a

air sample from one inch off the painted walls of this room
Measuring scale .05-1.0 ppm
Results below detectable levels at 5 strokes.

Gastec gas detection tube system was used to take a air sample from one inch above the floor
Measuring scale <.05-1.0 ppm
Results below detectable levels at 10 strokes.

Gastec gas detection tube system was used to take a air sample from the fire place
Measuring scale <.05-1.0 ppm
Results below detectable levels at 10 strokes.

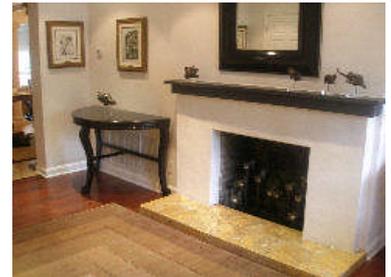
PHOTO 4

Paint may be 6 months old and the odor did not appear to be a paint odor.

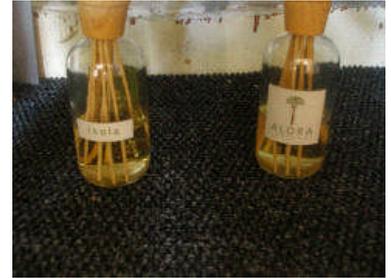
PHOTO 5

AC return is in the area and is near the crawl space below, it may be possible that the air handler is pulling odors from the crawl space into the house.

Inspector observed two air fresheners under the air handler and these will add chemicals and odors to the air but the odor these air fresheners were producing were not the same odors detected in the foyer, also client installed the air fresheners after the odor in order to cover the odor up.

Inspector turned up carper under the air handler and smelled for odors, roach odors were detected to be coming up from the crawl space below this area and roach droppings were observed on the old original wood floor under the carper, roach droppings and odors are completely expected in such an area in an older home.

Seal the floor under and the walls around the air handler in the closet near the kitchen, this will keep the AC unit from pulling in crawl space air.

1)The holes in the AC closet walls and floors allow the AC to suck hot humid air in from the attic via the hallow walls, and also from the crawl space below the floor. The floor and walls will have to be sealed.

Client is highly recommended to have the openings in the bottom and top of the closet wall in this area sealed, and also client should have the floor in this area sealed as well because this air handler will pull odors and allergens from inside the walls and floor of this closet.

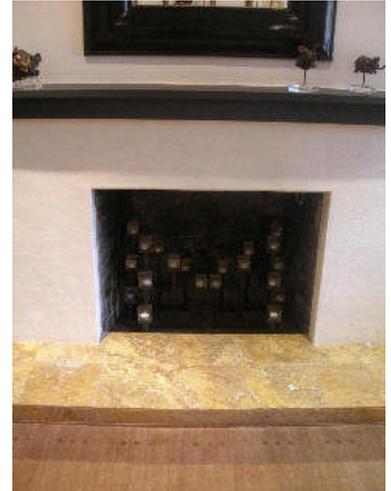
PHOTO 6

Client felt that the odors may be entering the house from the chimney however the bottom of the chimney was observed to be sealed from access to the crawl space air.
The interior of the air handler was inspected and found to be very clean and free of any odors.

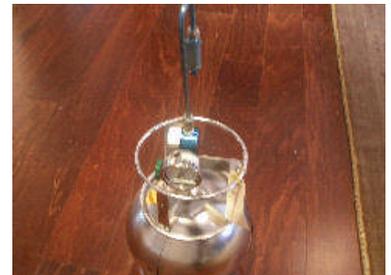
PHOTO 7

It appears likely that someone has dumped gasoline in the crawl space under the house in the past.

Attic was inspected from the access and appeared to be free of the suspect odor.

Crawl space under the house looked typical but inspector detected a strong chemical odors under the crawl space, the odor is a very strong odor chemical / volatile organic compound odor that is hard to describe. It is similar to the one in the front but is much stronger and appears to be the source of the front foyers areas odor. It may be pesticide odors or other chemicals. A soil sample was taken from the crawl space.

Two to-15 air samples were taken from the house, one in the front foyer area and another from the dining room area.

In order to control this problem have the crawl space encapsulating with thick plastic sheets and isonene foam insulation floor walls and ceiling / subfloor.

Have the crawl space air vented to the exterior this will create negative pressure in the crawl space thus making it very difficult for air to escape upward through the floor. This will also remove some of the chemicals from the crawl space.

A dehumidifier will have to be used in the crawl space and drained outside, this will have to be done constantly or humidity and mold problems will form in the sealed crawl space.
